New Hampshire Volunteer Lake Assessment Program

2002 Bi-Annual Report for Great Pond Kingston

NHDES
Water Division
Watershed Management Bureau
6 Hazen Drive
Concord, NH 03301

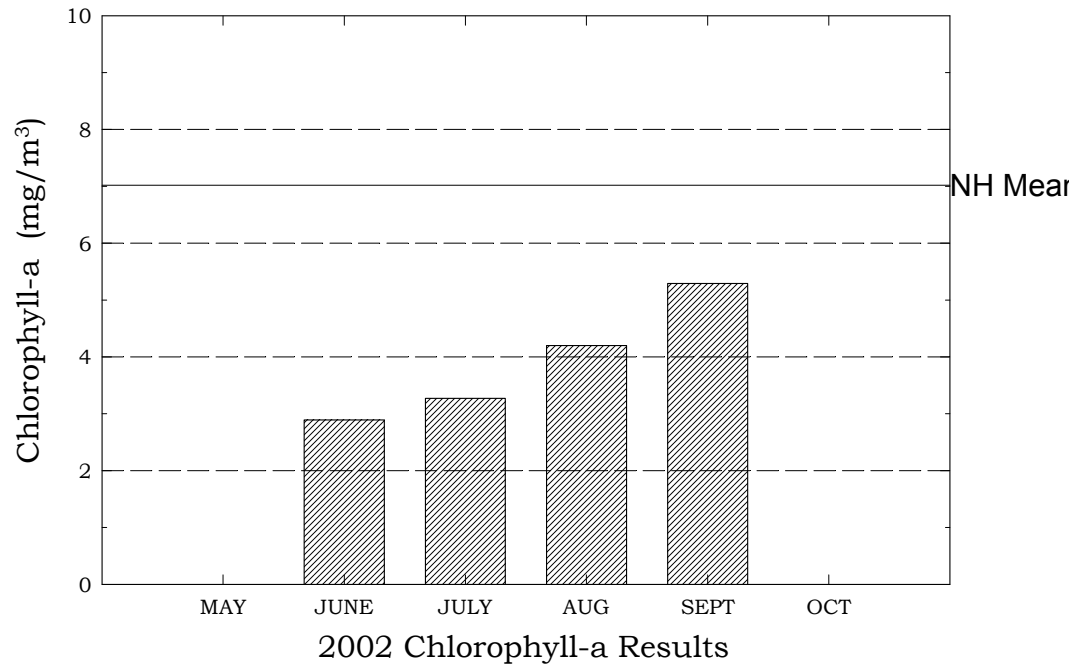
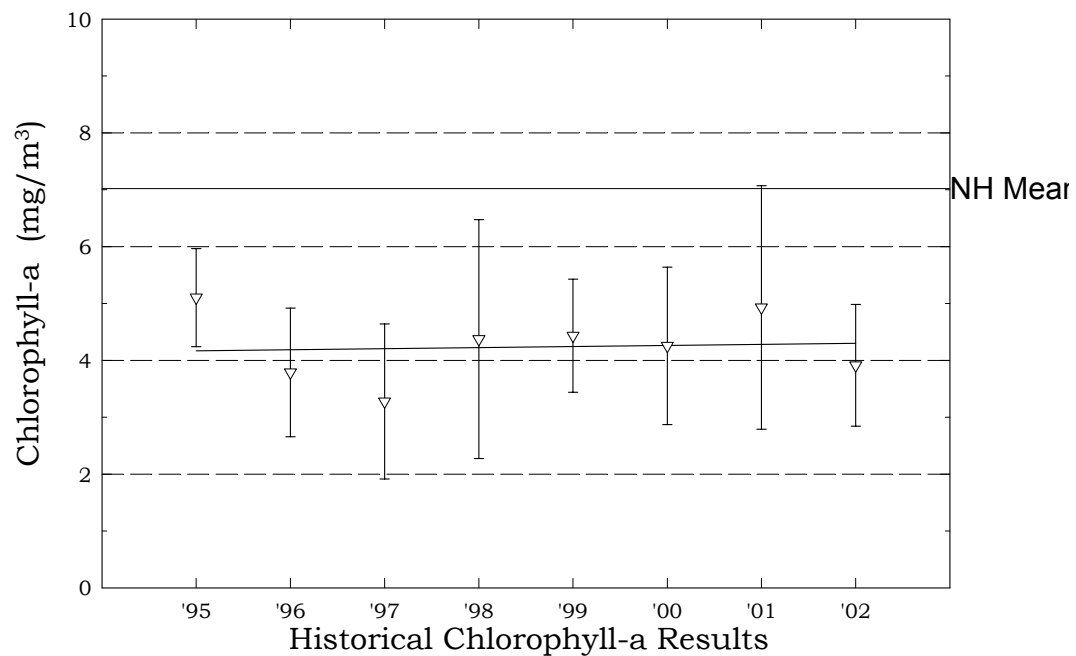
Figure 1. Monthly and Historical Chlorophyll-a Results

The current year data (the top graph) show that the chlorophyll-a concentration **increased steadily** from June to September. The chlorophyll-a concentration on each sampling event was **less than** the state mean.

The historical data (the bottom graph) show that the 2002 chlorophyll-a mean is **less than** the state mean.

Overall, visual inspection of the historical data trend line (the bottom graph) shows **a relatively stable** in-lake chlorophyll-a trend since monitoring began in 1995. Specifically, the mean annual chlorophyll concentration has ranged between approximately **3 and 5 mg/L** since monitoring began.

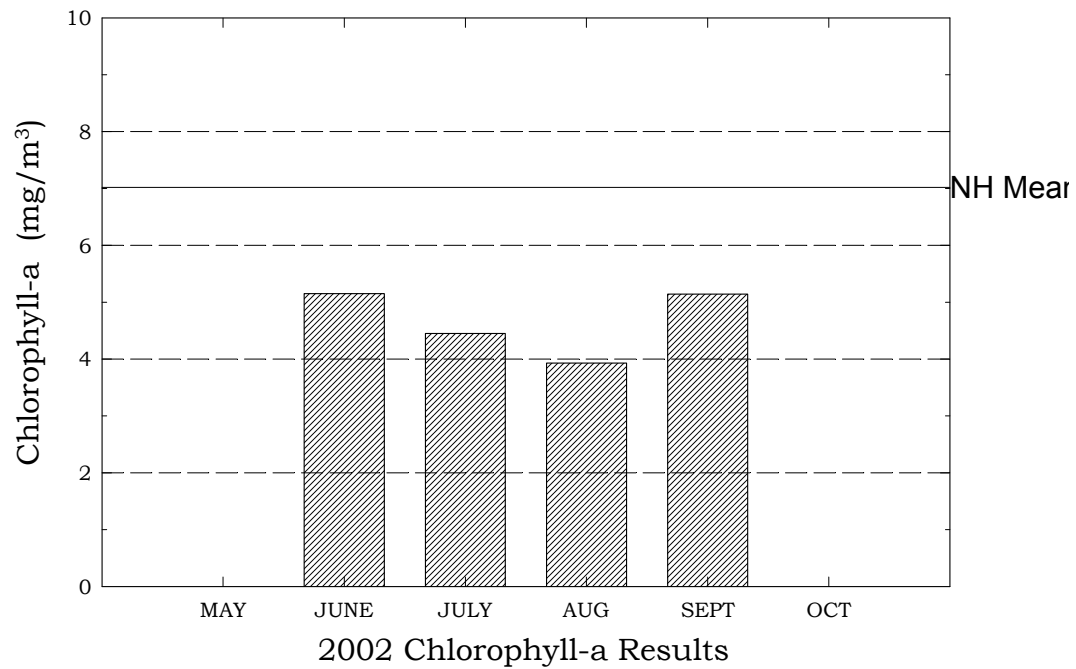
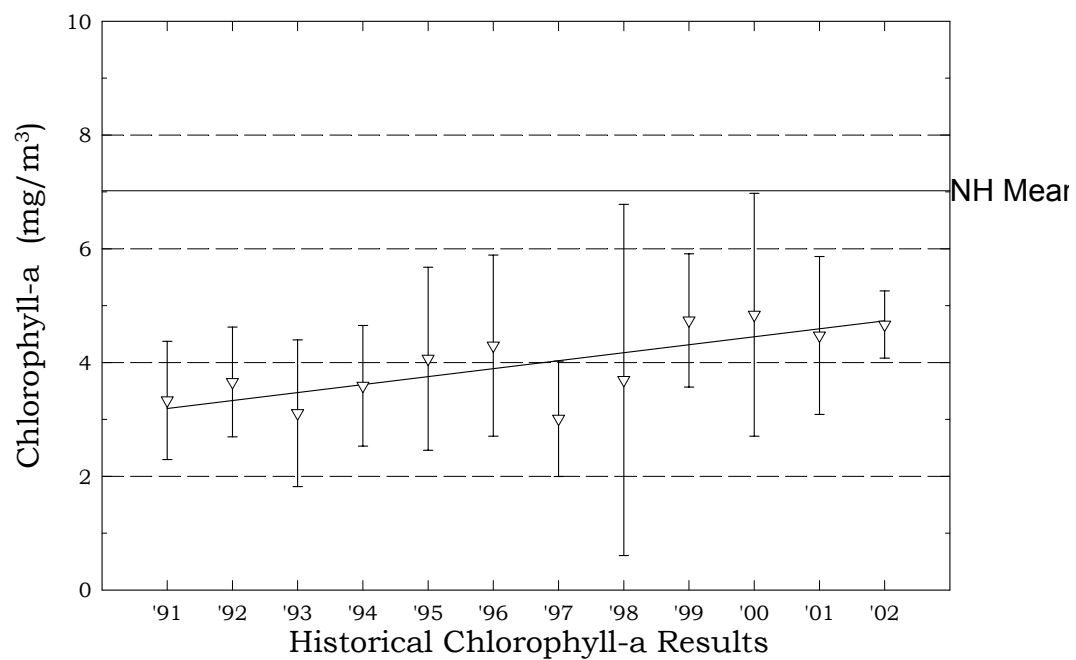
Figure 1. Monthly and Historical Chlorophyll-a Results

The current year data (the top graph) show that the chlorophyll-a concentration **decreased gradually** from June to August, and then **increased** from August to September. The chlorophyll-a concentration on each sampling event was **less than** the state mean.

The historical data (the bottom graph) show that the 2002 chlorophyll-a mean is **less than** the state mean.

Overall, the statistical analysis of the historical data show that the chlorophyll-a concentration has **significantly increased** since monitoring began. Specifically, the chlorophyll-a concentration has **increased** (meaning **worsened**) on average by approximately **3.3 percent** per sampling season during the sampling period **1991 to 2002**. (Note: Please refer to Appendix E for the statistical analysis explanation and data print out.)

While algae are naturally present in all lakes/ponds, an excessive or increasing amount of any type is not welcomed. In freshwater lakes/ponds, phosphorus is the nutrient that algae depend upon for growth. Therefore, algal concentrations may increase when there is an increase in nonpoint sources of nutrient loading from the watershed, or in-lake sources of phosphorus loading (such as phosphorus releases from the sediments). It is important to continually educate residents about how activities within the watershed can affect phosphorus loading and lake quality.

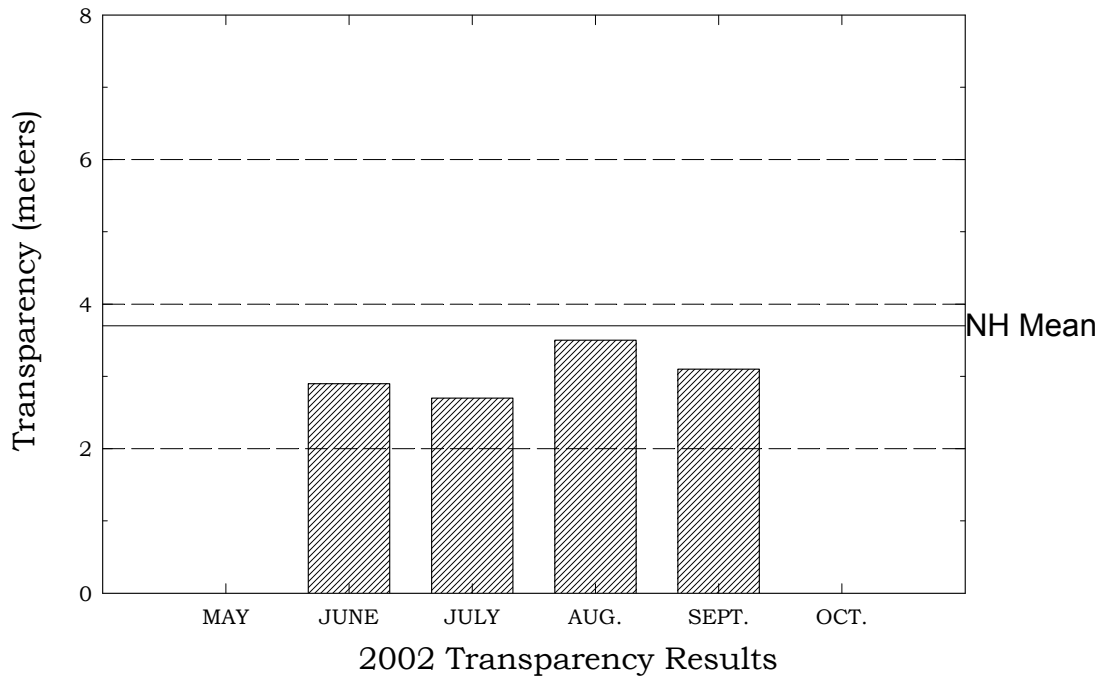
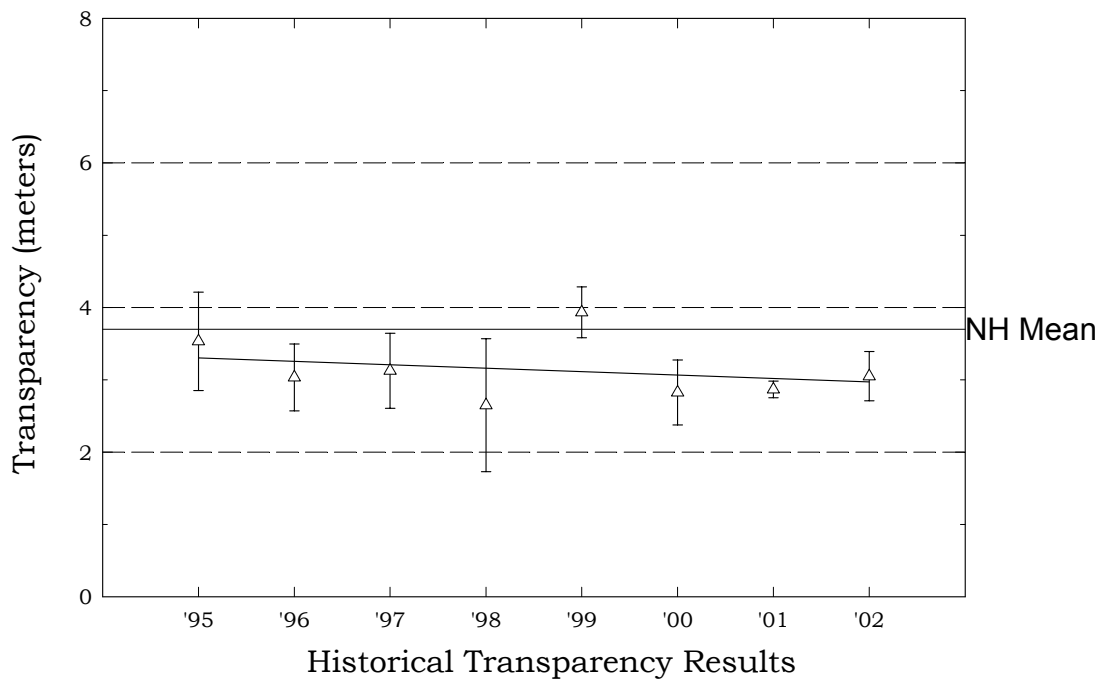
Figure 2. Monthly and Historical Transparency Results

The current year data (the top graph) show that the in-lake transparency **decreased slightly** from June to July, **increased slightly** from July to August, and then **decreased very slightly** from August to September.

The historical data (the bottom graph) show that the 2002 mean transparency is **less than** the state mean.

Overall, visual inspection of the historical data trend line (the bottom graph) shows **a relatively stable** trend for in-lake transparency since monitoring began. Specifically, the transparency has ranged between approximately **3** and **4** meters since monitoring began in 1995.

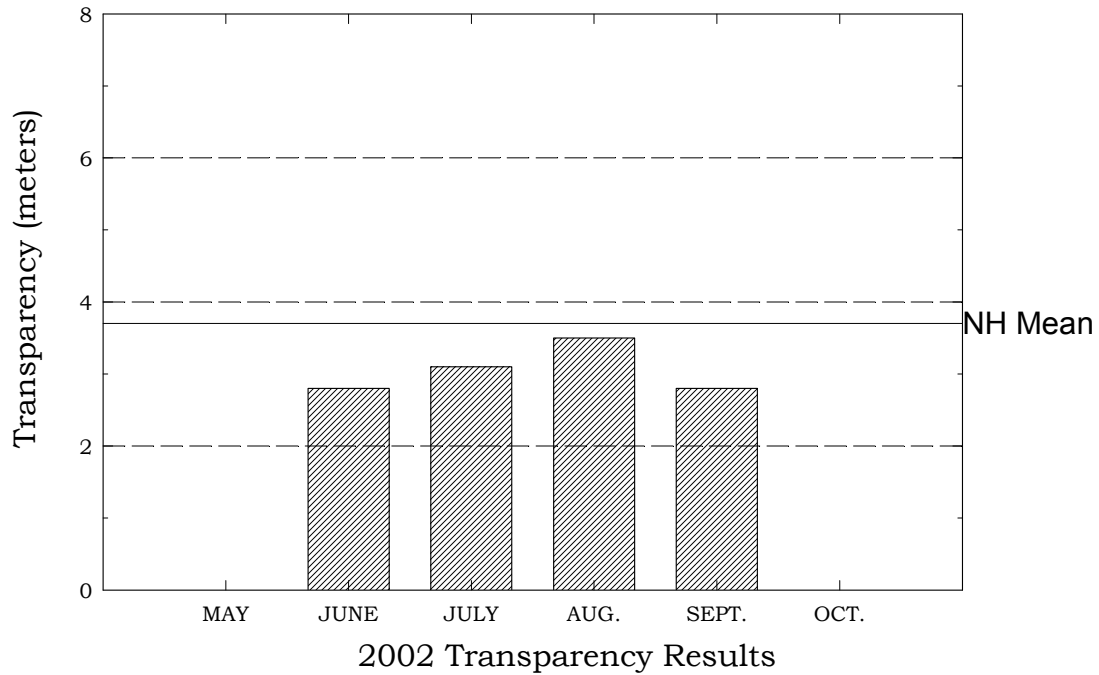
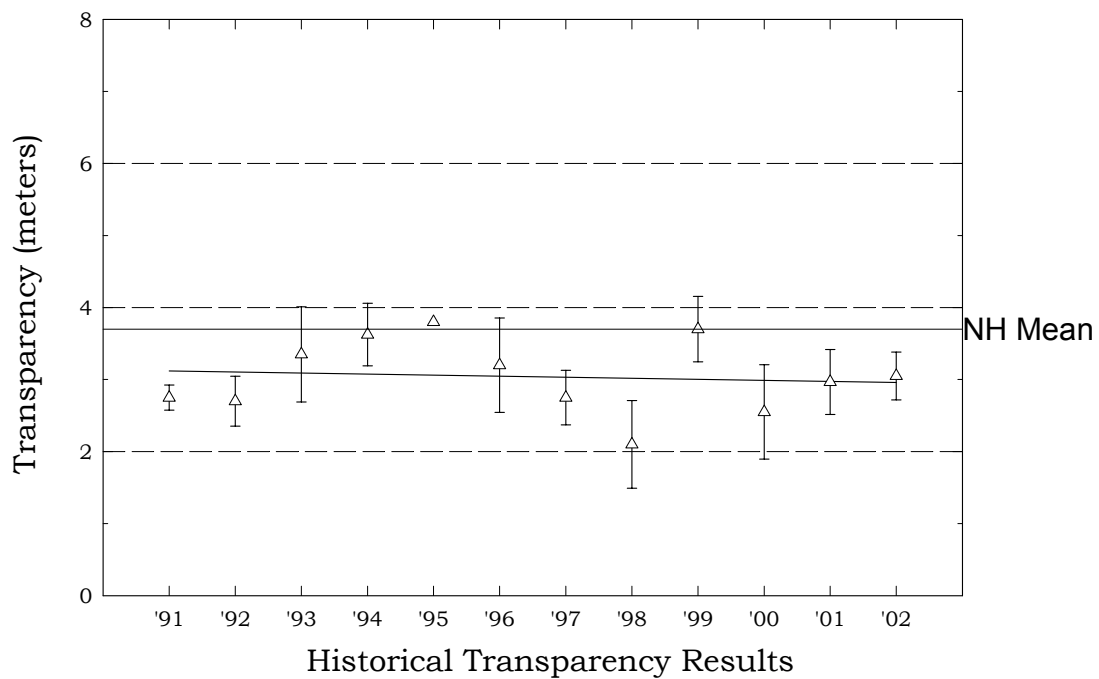
Figure 2. Monthly and Historical Transparency Results

The current year data (the top graph) show that the in-lake transparency **increased very gradually** from June to August, and then **decreased** from August to September.

The historical data (the bottom graph) show that the 2002 mean transparency is **less than** the state mean.

Overall, the statistical analysis of the historical data (the bottom graph) show that the mean annual in-lake transparency has **not significantly changed** (either *increased* or *decreased*) since monitoring began in **1991**. Specifically, the in-lake transparency has **varied** (meaning **fluctuated**), but has not *continually increased* or *decreased* since monitoring began. (Note: Please refer to Appendix E for the statistical analysis explanation and data print out.)

Typically, high intensity rainfall causes erosion of sediments into lakes/ponds and streams, thus decreasing clarity. Efforts should continually be made to stabilize stream banks, lake/pond shorelines, disturbed soils within the watershed, and especially dirt roads located immediately adjacent to the edge of tributaries and the lake/pond. Guides to Best Management Practices designed to reduce, and possibly even eliminate, nonpoint source pollutants, such as sediment loading, are available from NHDES upon request.

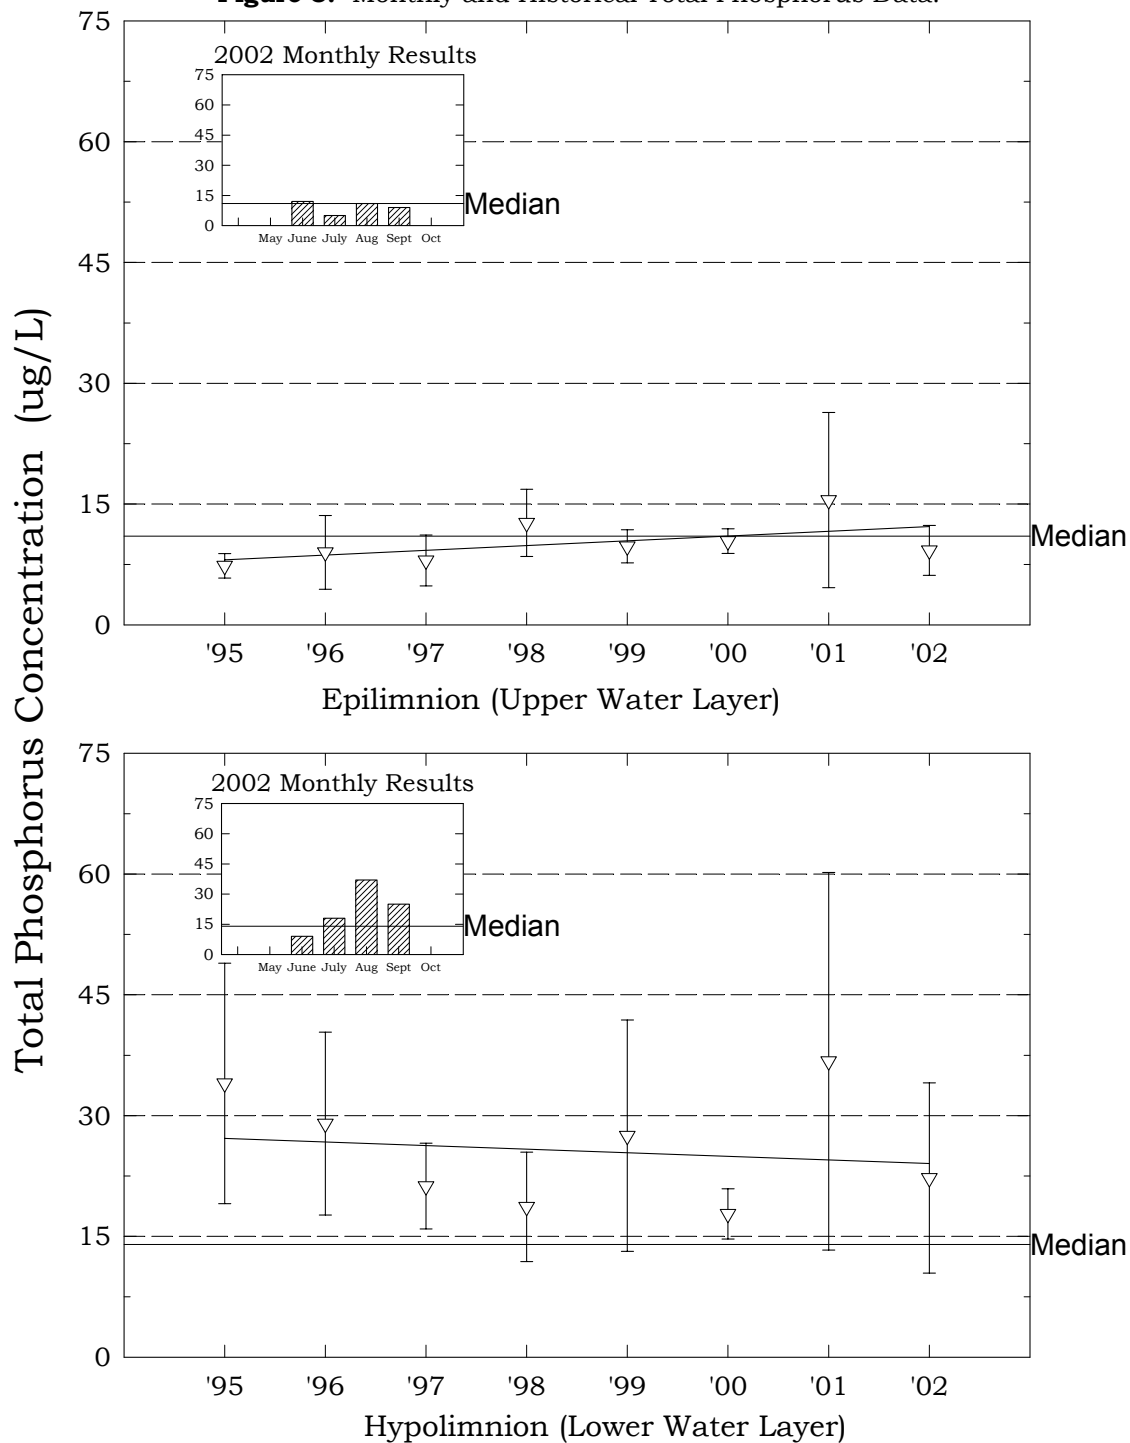
Figure 3. Monthly and Historical Total Phosphorus Data.

The current year data for the epilimnion (the top inset graph) show that the total phosphorus concentration **decreased** from June to July, **increased** from July to August, and then **decreased slightly** from August to September.

The historical data show that the 2002 mean epilimnetic total phosphorus concentration is **slightly less than** the state median.

The current year data for the hypolimnion (the bottom inset graph) show that the total phosphorus concentration **increased steadily** from June to August, and then **decreased** from August to September.

The historical data show that the 2002 mean hypolimnetic total phosphorus concentration is ***much greater than*** the state median.

Overall, visual inspection of the historical data trend line for the epilimnion show ***a relatively stable*** total phosphorus trend, which means that the concentration has ***remained approximately the same*** in the epilimnion since monitoring began in 1995.

Overall, visual inspection of the historical data trend line for the hypolimnion shows ***a variable*** total phosphorus trend. This means that the mean annual concentration has ***fluctuated***, but has not *continually increased* or *decreased* since monitoring began in 1995.

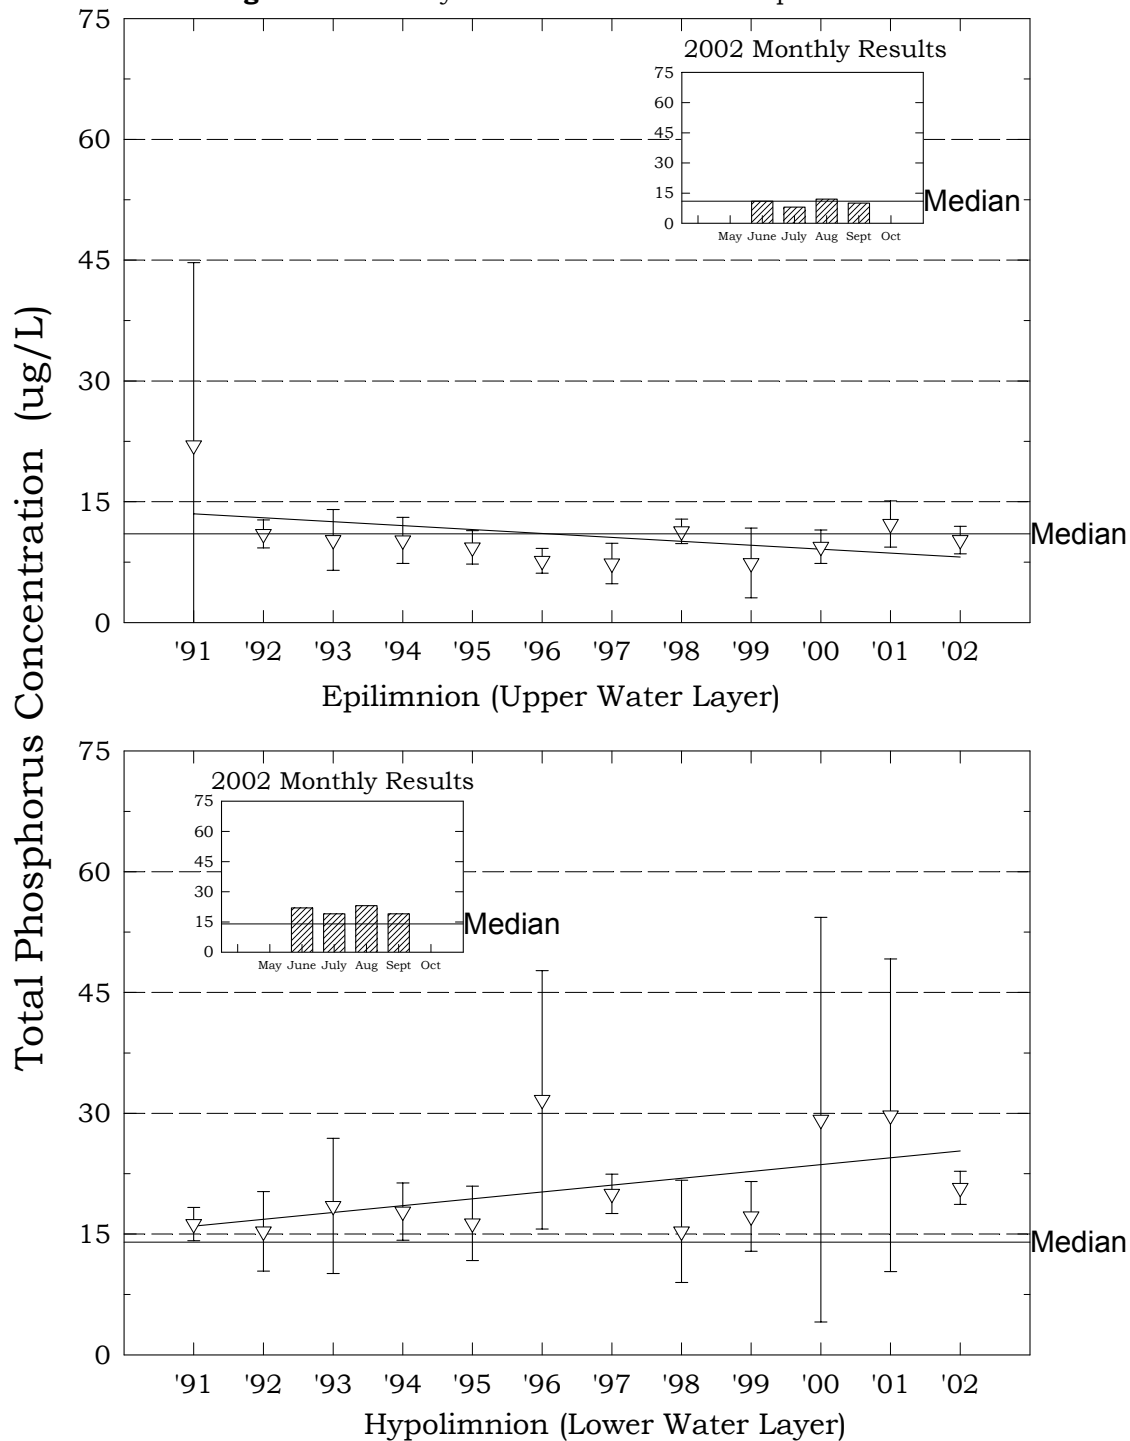
Figure 3. Monthly and Historical Total Phosphorus Data.

The current year data for the epilimnion (the top inset graph) and the hypolimnion (the bottom inset graph) show that the total phosphorus concentration ***decreased*** from June to July, ***increased*** from July to August, and then ***decreased*** from August to September.

The historical data show that the 2002 mean epilimnetic total phosphorus concentration is ***approximately equal to*** the state median.

The historical data show that the 2002 mean hypolimnetic total phosphorus concentration is ***greater than*** the state median.

Overall, the statistical analysis of the historical data show that the total phosphorus concentration in the epilimnion (upper layer) and the hypolimnion (lower layer) has ***not significantly changed*** (either *increased* or *decreased*) since monitoring began in **1991**. Specifically, the total phosphorus concentration in the epilimnion has remained ***relatively stable*** and has been ***approximately equal to*** the state median. The total phosphorus concentration in the hypolimnion has ***varied*** (meaning ***fluctuated***), but has not *continually increased* or *decreased* since monitoring began. (Note: Please refer to Appendix E for the statistical analysis explanation and data print out.)

One of the most important approaches to reducing phosphorus loading to a waterbody is to continually educate watershed residents about its sources and how excessive amounts can adversely impact the ecology and value of lakes and ponds. Phosphorus sources within a lake or pond's watershed typically include septic systems, animal waste, lawn fertilizer, road and construction erosion, and natural wetlands. If you would like to educate watershed residents about how they can help to reduce phosphorus loading into the lake/pond, please contact the VLAP Coordinator.
